# TRUST THE BANANA TRUSS

## CONCEPT

# LOAD TESTING

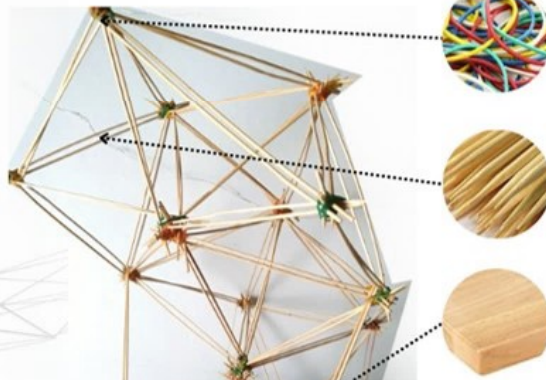
### Important Dimensions

The triangulation of structural elements allowed the conception of a sculpture-like design. The modules also were carefully arranged with one another to form a diamond-like structure when seen from the rear (please see rear elevation). Additional bracing (rubber bands and sticks) was also placed at the sides to make the structure more cohesive.

Right Side Elevation

Left Side Elevation

Front Elevation

Rear Elevation

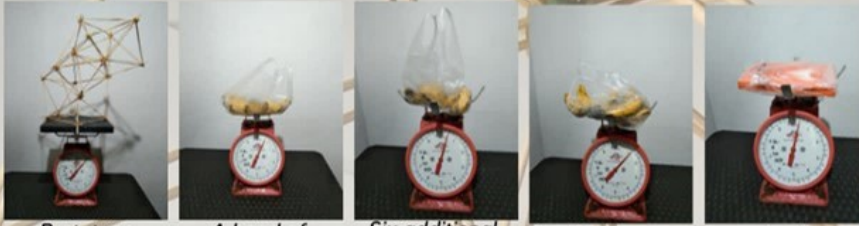
Prototype

A hand of banana

Six additional bananas

hand of banana plus the additional bananas

book

Load	Weight (Kg)
Prototype	1.15
Hand of banana (8 bananas)	0.675
Additional 6 bananas	0.5 (approx. 0.083 per pc.)
Book	0.35

The prototype and all the loads used were weighed using a typical weighing scale. The prototype weighed a little over a kilogram while the minimum load required (a hand of banana) weighed a little over half a kilogram. Nevertheless, the minimum load and the additional load would weigh more than the weight of the prototype.

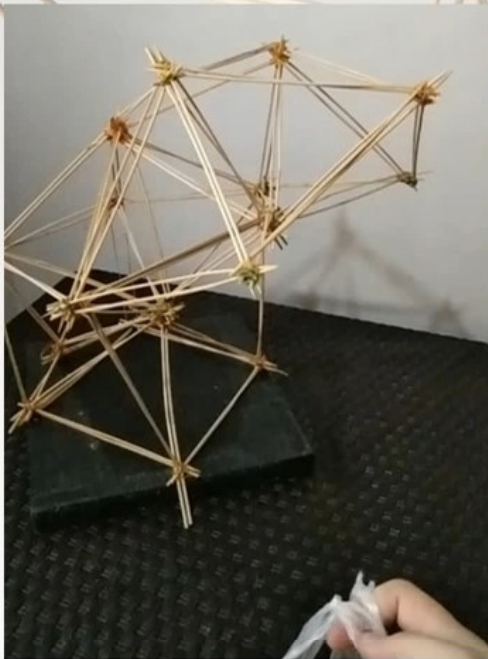
A hand of banana (video)

Although the structure showed some movement when the load was placed, the banana stand was able to fully support a hand of banana.

To check the capacity of the structure, more load was gradually applied through the addition of more bananas (one banana at a time). The six videos exhibit the reaction of the structure after the addition of one, two, three, four, five, and six additional fruits. As the number of loads increases, the deflection of the upper part of the structure becomes more evident. During the addition of four bananas, the displacement was estimated to be an inch.

Nevertheless, no physical damage or rupture was recorded.

Additionally, the structure bounces back to its original form once the loads were removed. This movement or deflection was assumed to be the consequence of using rubber bands as the tension-bracing material at the back of the structure. The use of sticks or other rigid materials might help prevent this.

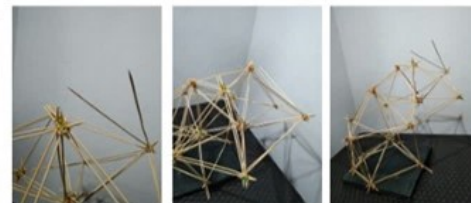
Weight (Kg)
Instability/Deflection/Buckling	0.675
Physical Damage/Slight Rupture	1.475
Complete Collapse/Damage	None
